# Property and Timber Pest Report

Inspection Date: 28 Aug 2026

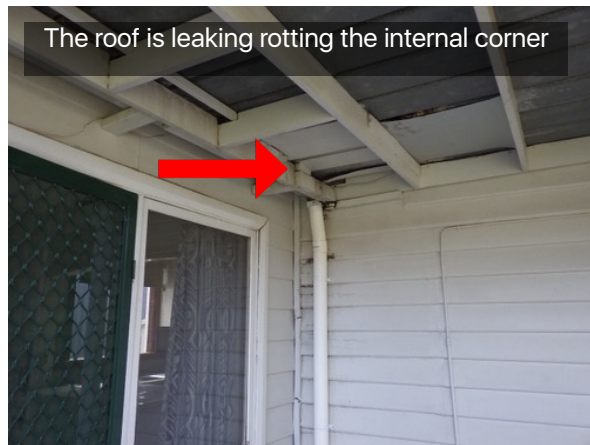
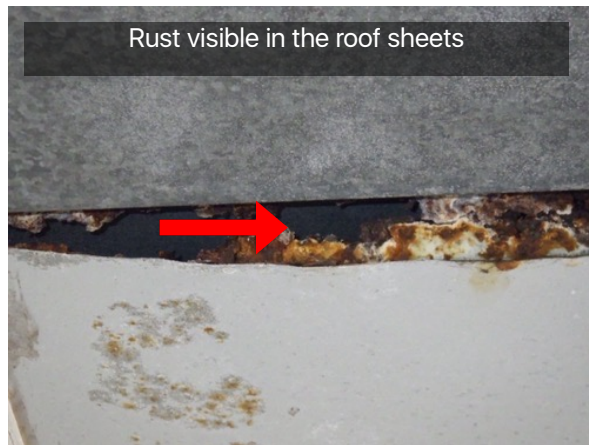
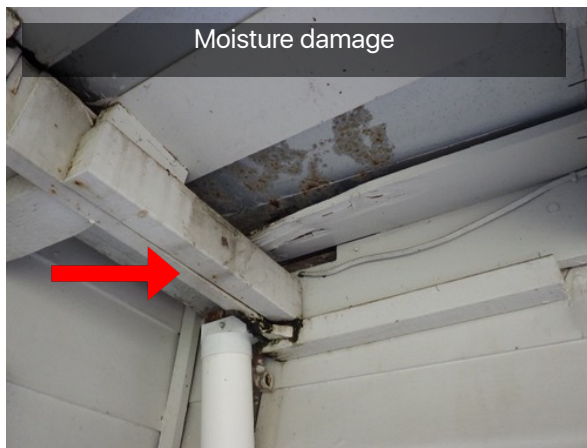
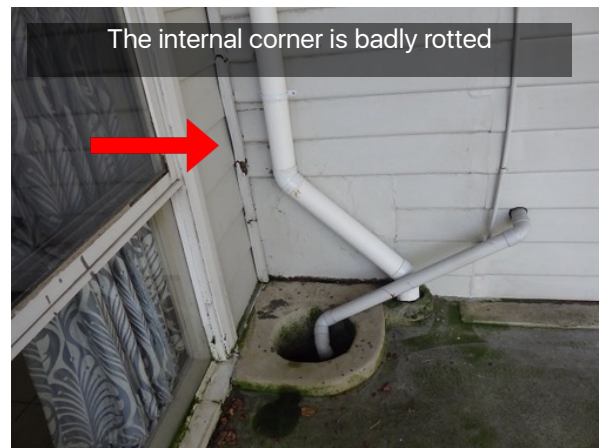
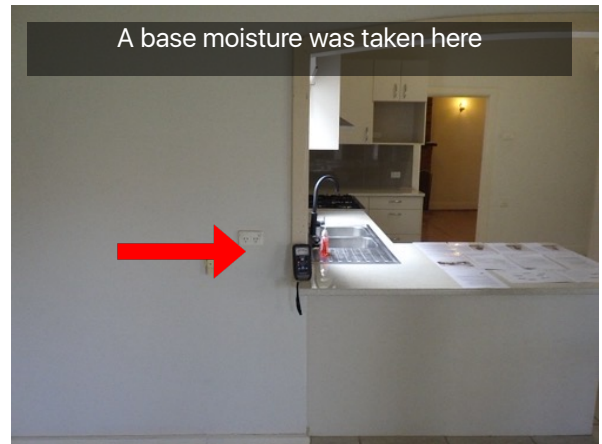
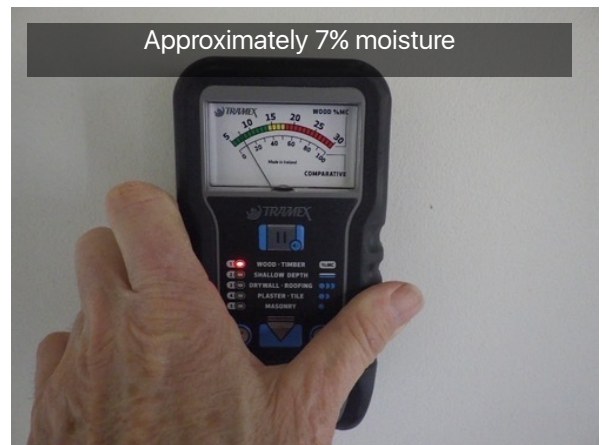
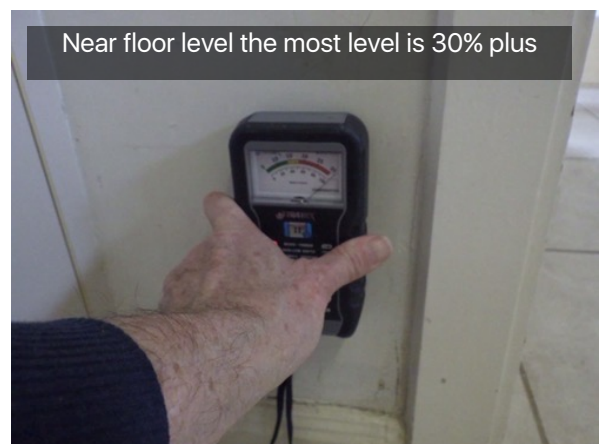
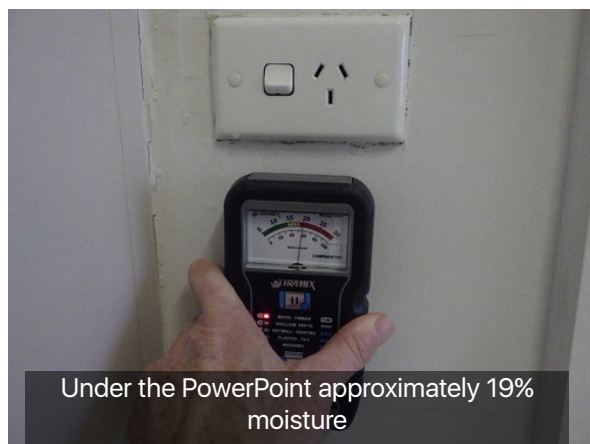
### Major Defect 1.01

**Finding:** Moisture damage

The internal corner of the pergola at the junction between the extension and the original house, the roof is badly rusted allowing moisture to penetrate down into the weatherboards rotting them badly.

When moisture levels were taken inside the house behind the badly moisture affected weatherboards high levels of moisture were detected on the internal wall.

This would infer the stud work in the wall is badly affected by moisture which may also have produced mould.

The metal roof above the pergola will also need to be replaced due to it being rusted through.

A qualified carpenter or builder should be engaged to carry this out.

This should be done as soon as practical, as if mould is inside the wall this is definitely a health hazard.

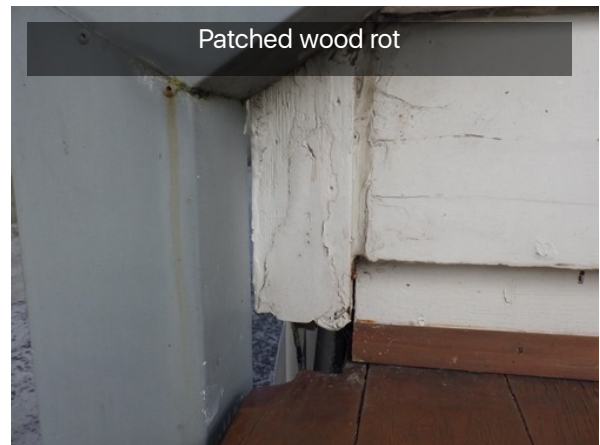
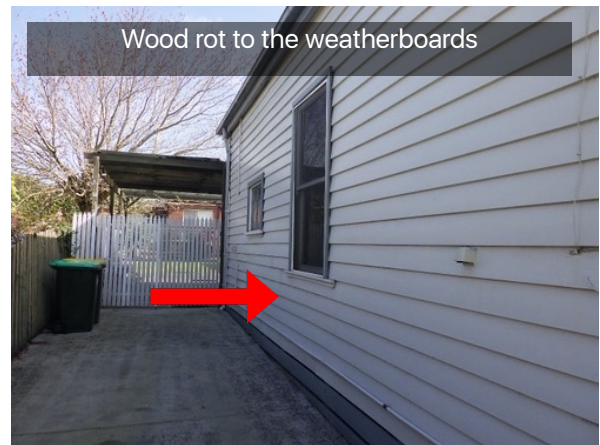
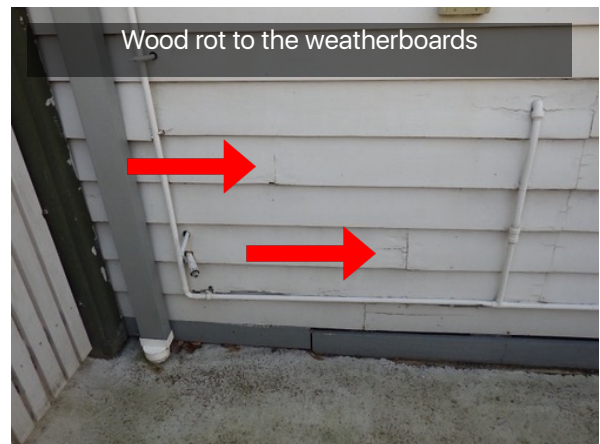
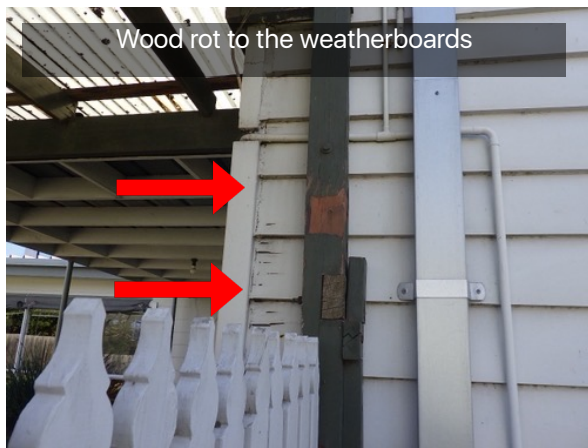
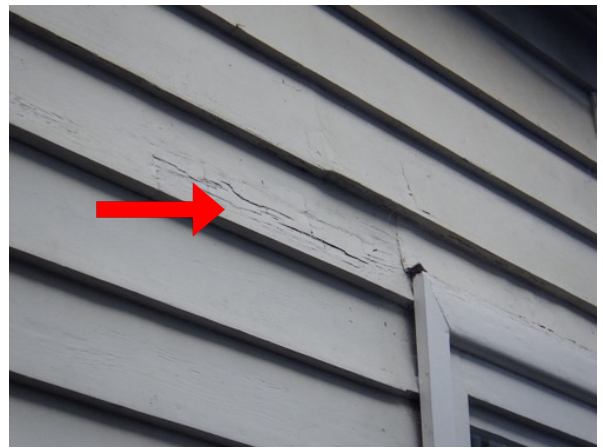
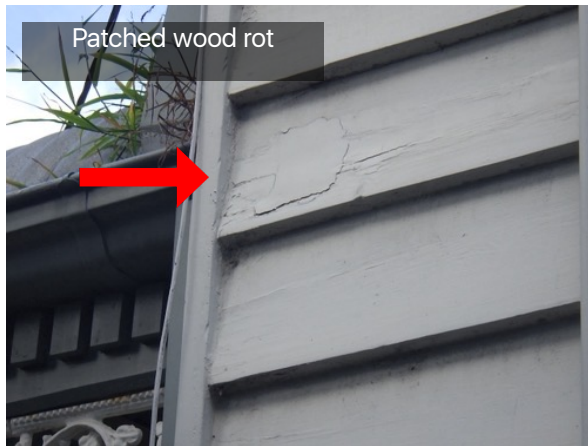
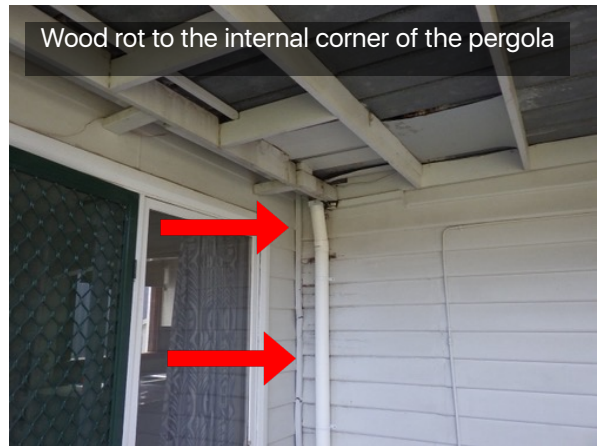
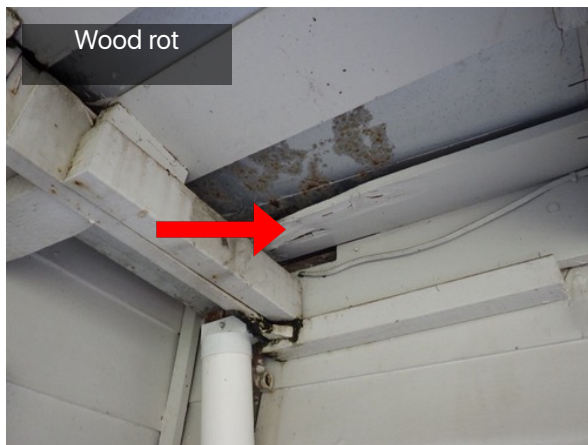
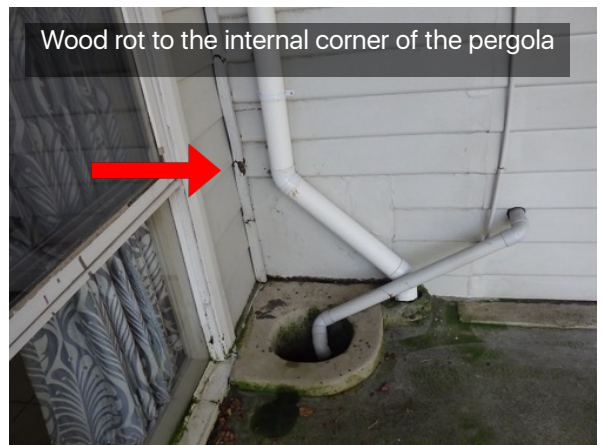
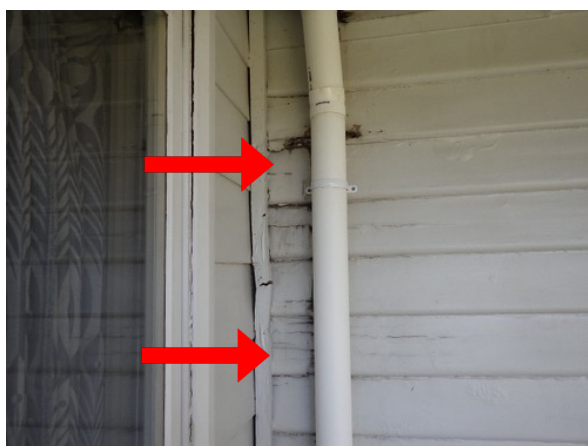
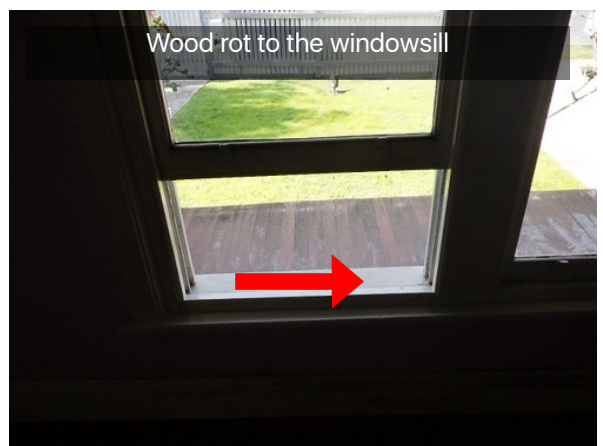
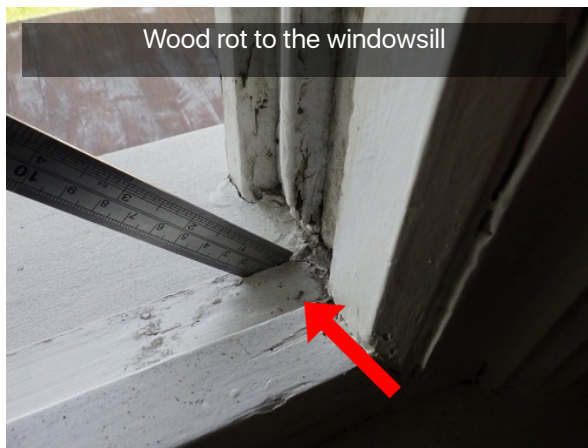
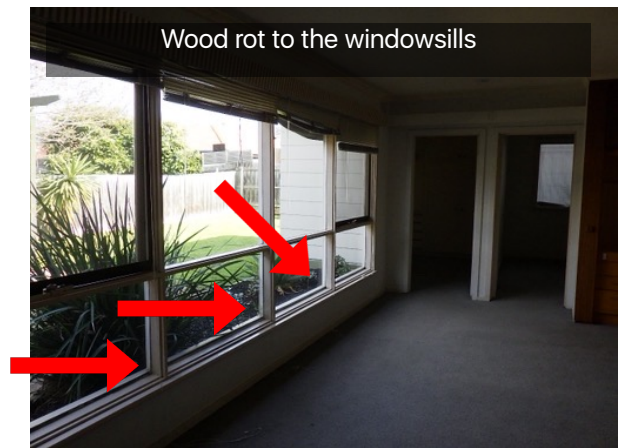
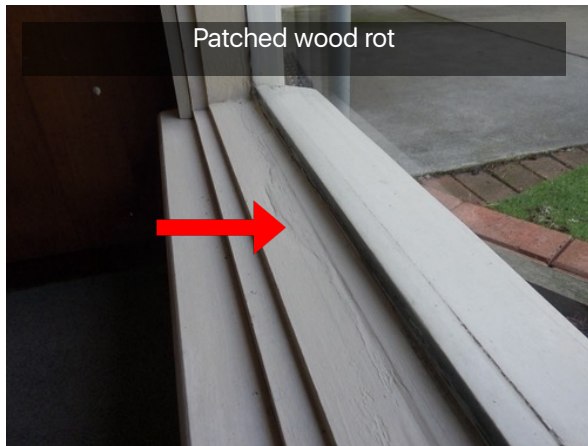
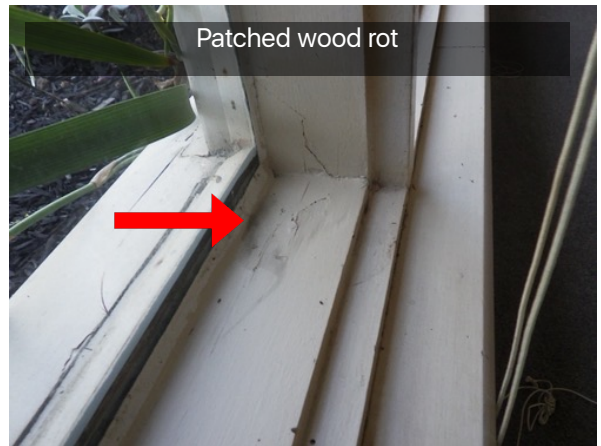
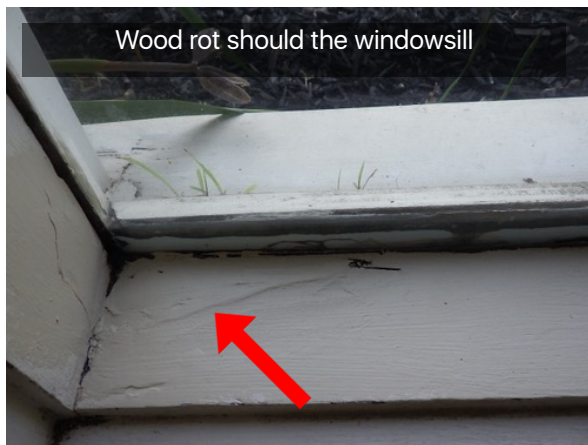
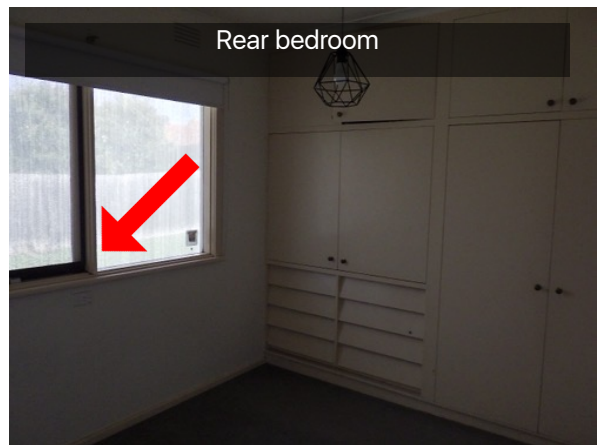
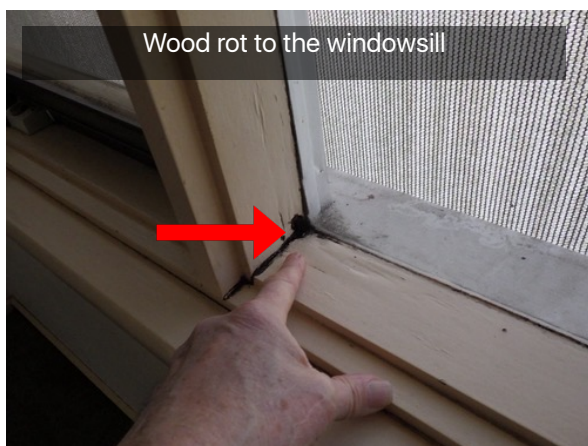
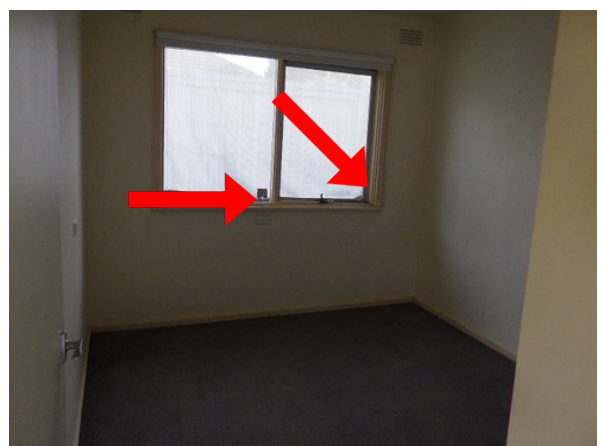
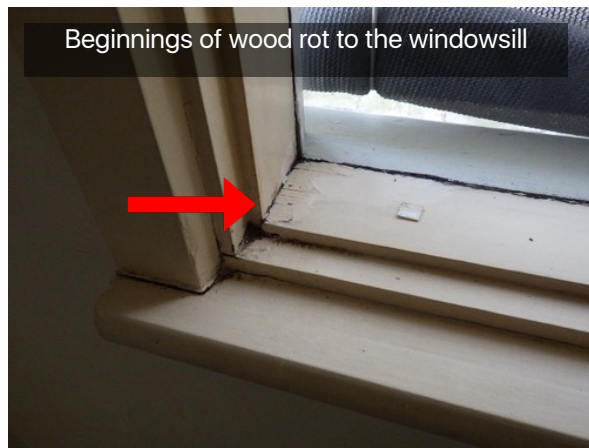
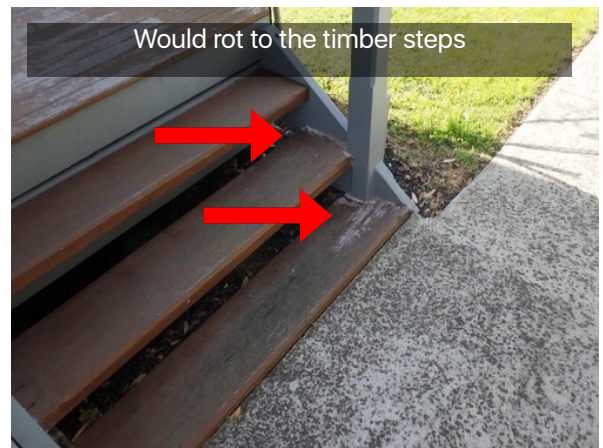
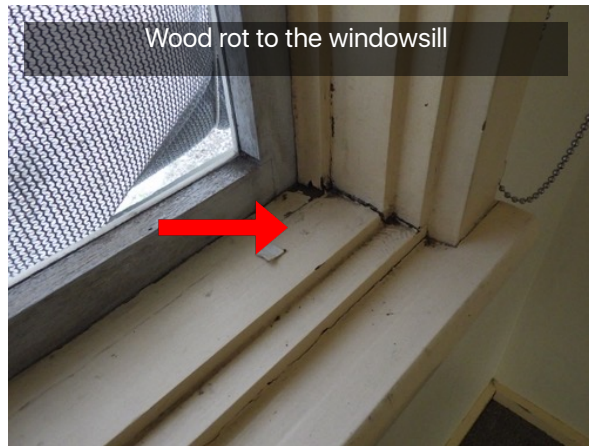
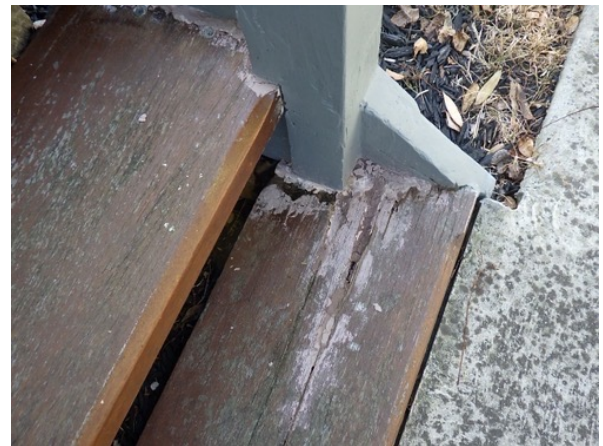
## Major Defect 1.03

**Finding:** Wood rot

Wood rot was identified in the weatherboards on all elevations windowsills and to the frame of the pergola of the rear of the property.

Wood rot is usually caused by prolonged exposure to moisture and or to the weather.

Proper maintenance may involve replacement of timber elements badly affected.

A qualified carpenter may be engaged to replace the timber as required.

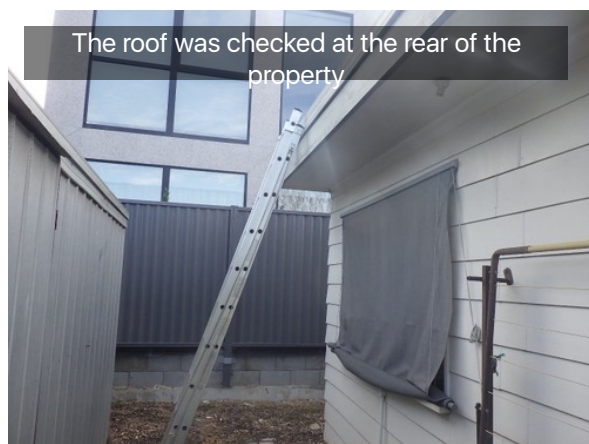
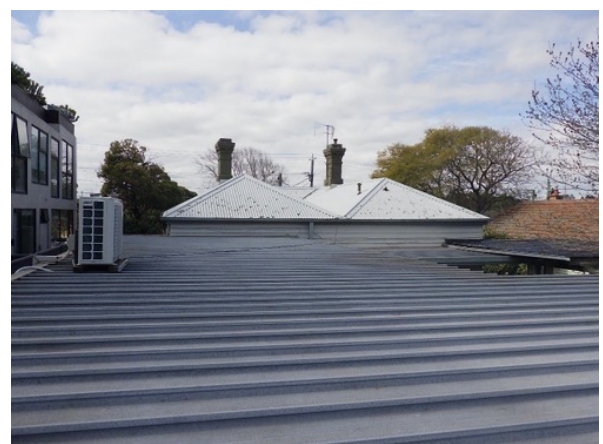
Rust is visible to the roof sheets in multiple locations

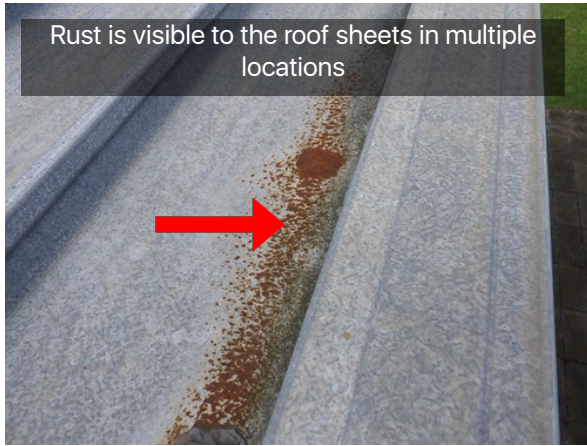
The roof is in poor condition with rust in multiple areas

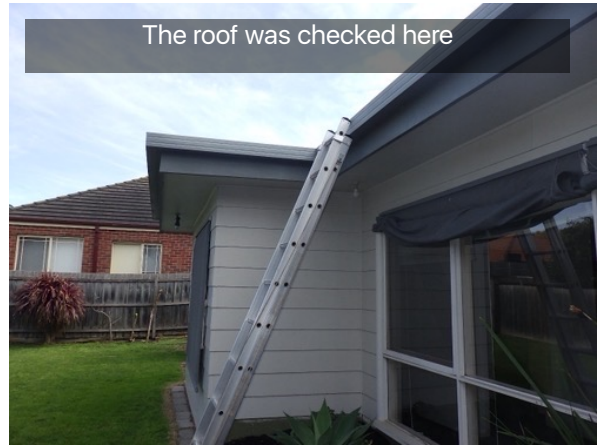
Rust to the high side of the roof sheets

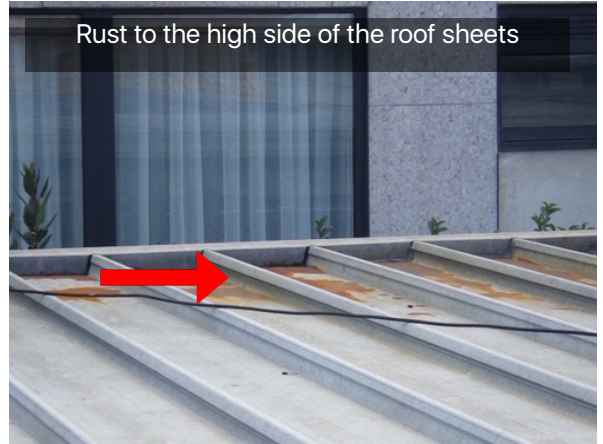
The roof is badly rusted

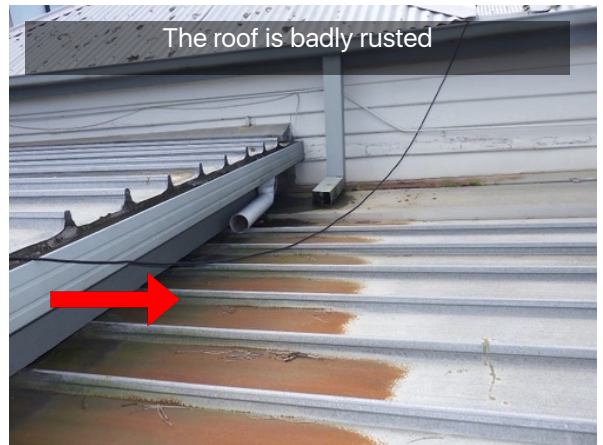
There is even grass growing on the roof which would hold moisture further rusting the roof

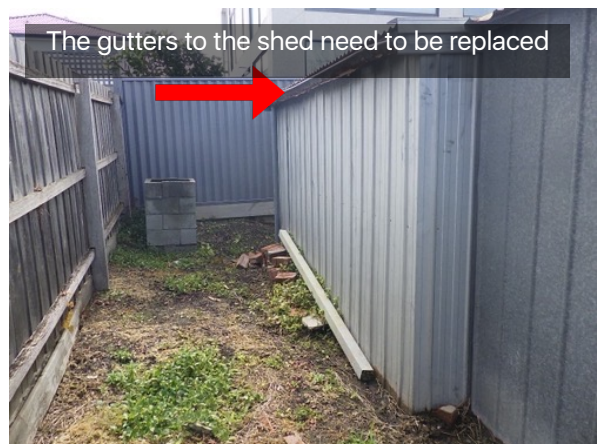
The gutters to the shed need to be replaced

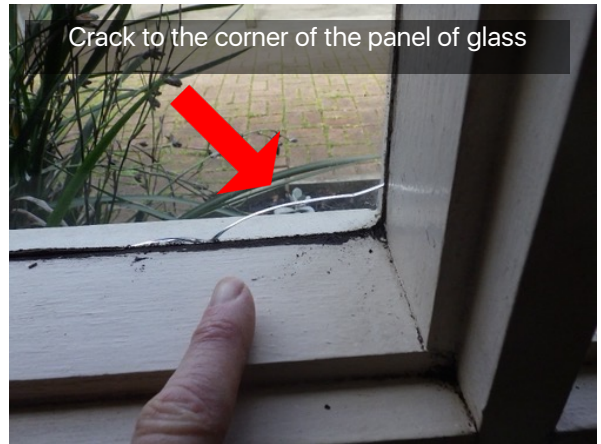
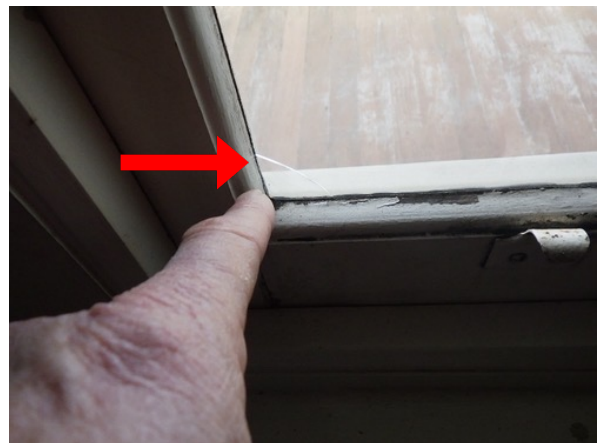
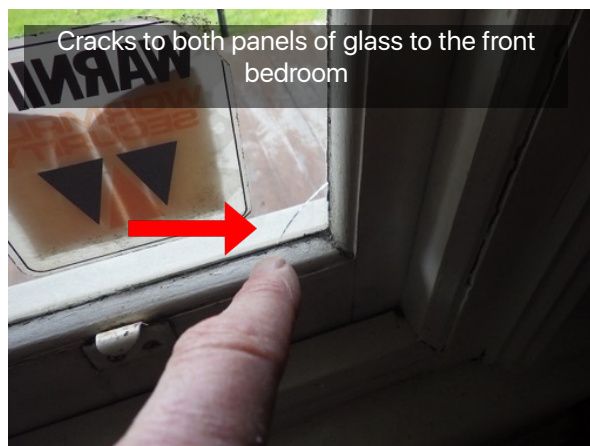
### Minor Defect 2.01

There are cracked panels of glass in the bedroom.

The panels should be replaced as soon as practical to prevent any personal injury.

This should be done by a qualified glazier at the owner's discretion

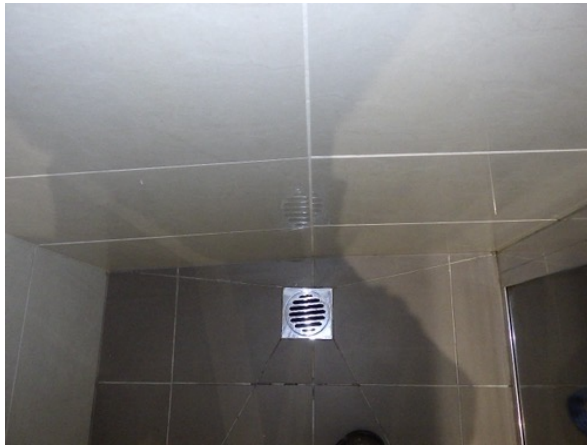
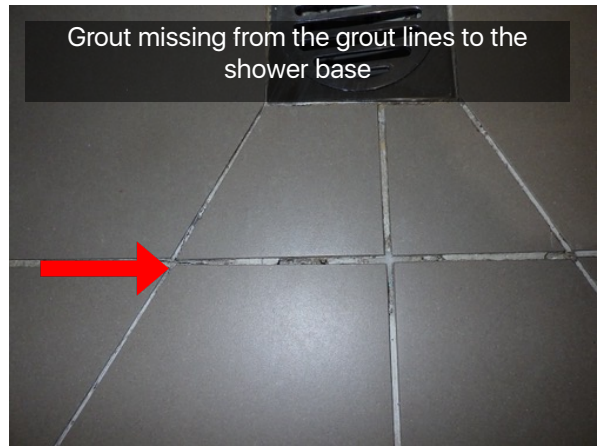
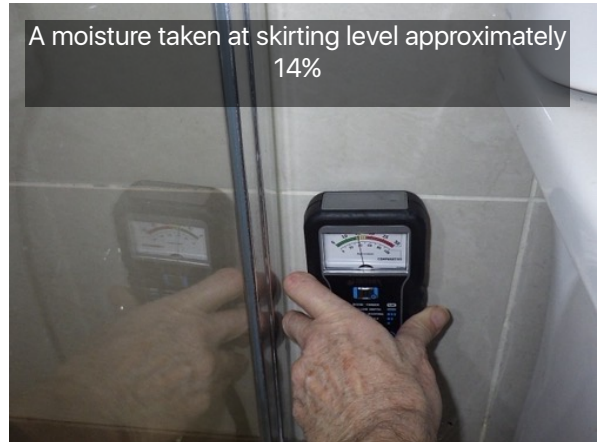
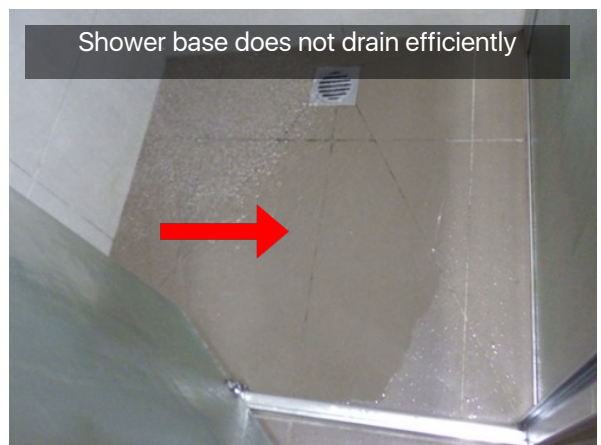
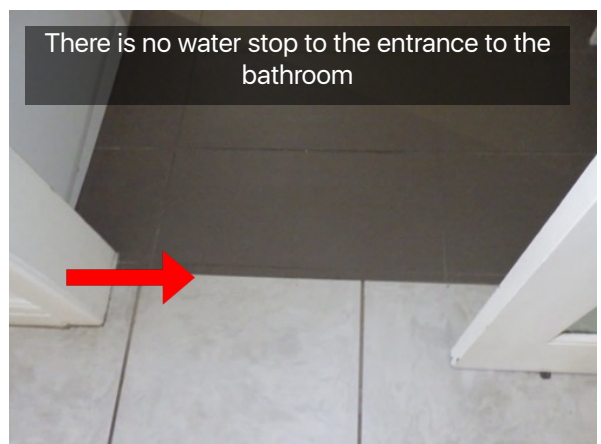
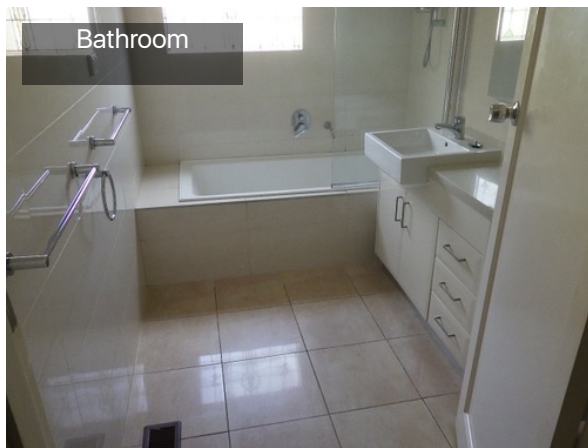
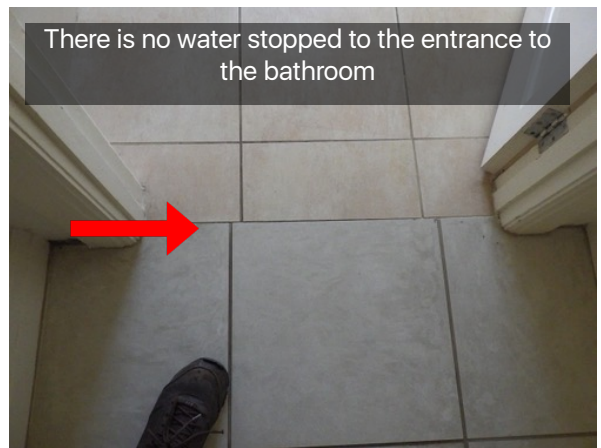
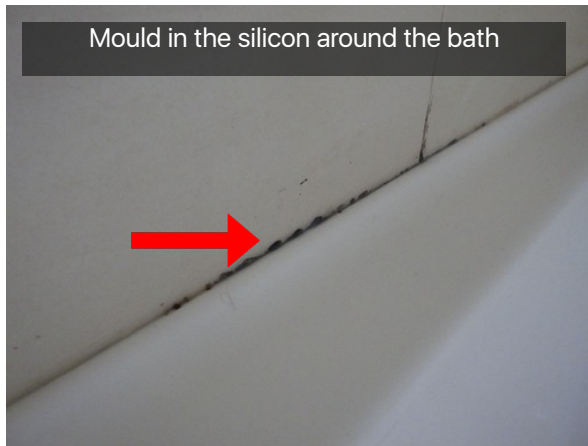
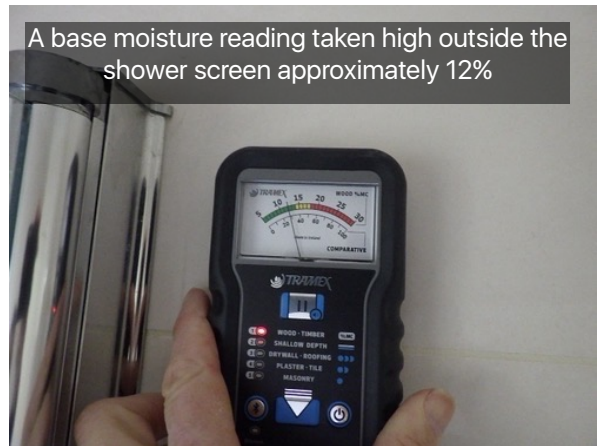
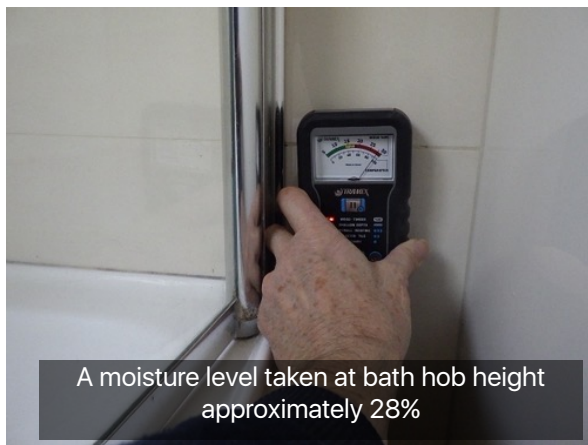
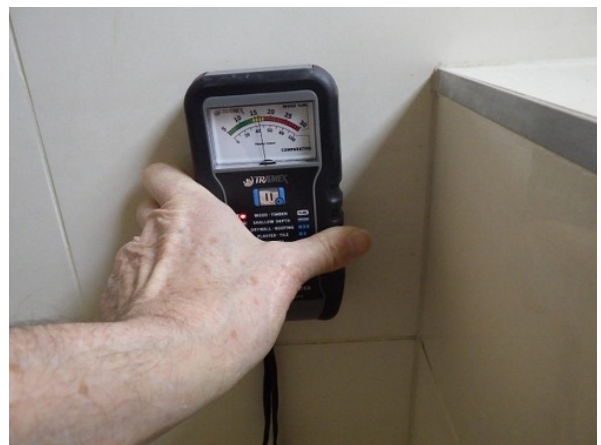
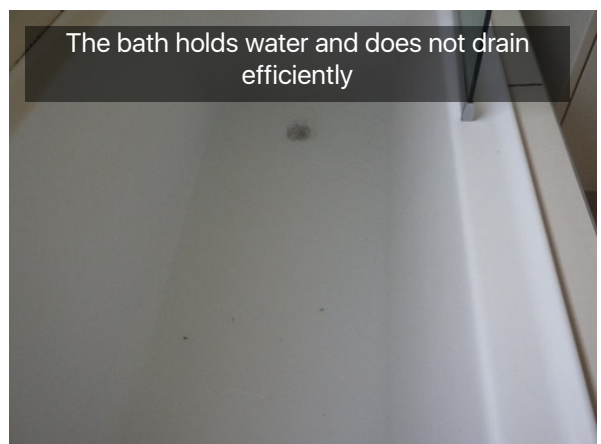
## Minor Defect 2.02

The silicone sealant was missing or deteriorated in the bathroom and kitchen. Silicone sealant is an important element in preventing moisture from penetrating into the substrate and possibly causing secondary damage to other building elements.

A competent handyman or sealant contractor could be engaged to remove and replace the existing silicone with an appropriate wet area silicone, this will ensure that you know that from the first day that you are in the property the seals are as they should be.

A plumber could be engaged to possibly send a camera down the sewer lines to find out if there are any blockages or the reason for the slow drainage of the bath and shower base.

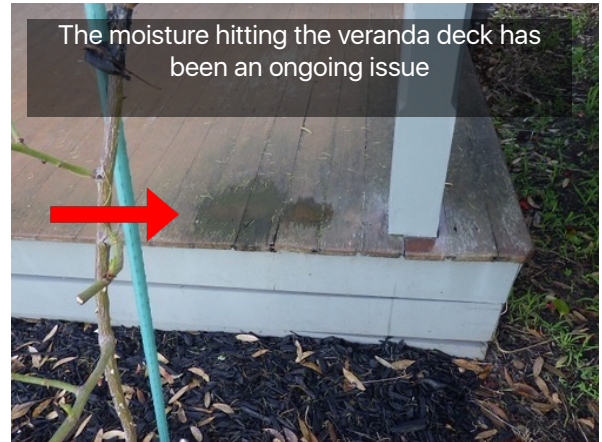
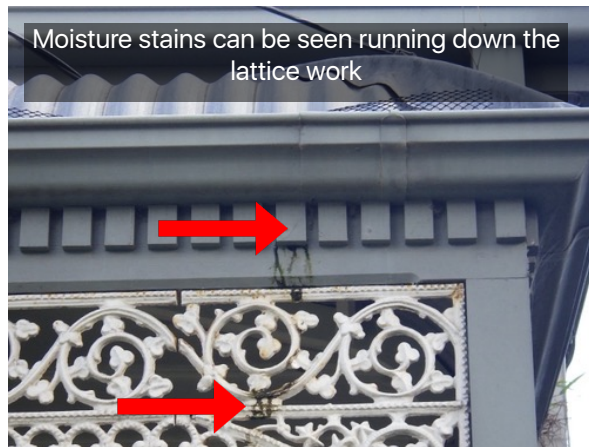
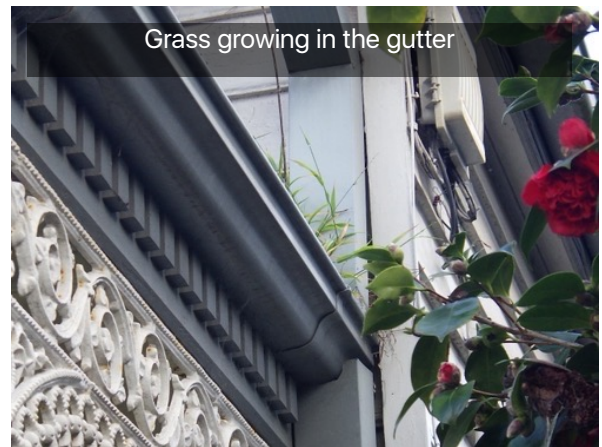
## Minor Defect 2.03

There are a number of gutters blocked with vegetation. There's also gutters that are rusted through allowing water to drip down onto the front veranda affecting the timber deck.

Where the gutters have rusted through they may need to be replaced.

A roof plumber should be engaged to fill the consult and provide advice on what needs to be replaced or rectified.

This should be done as soon as practical.

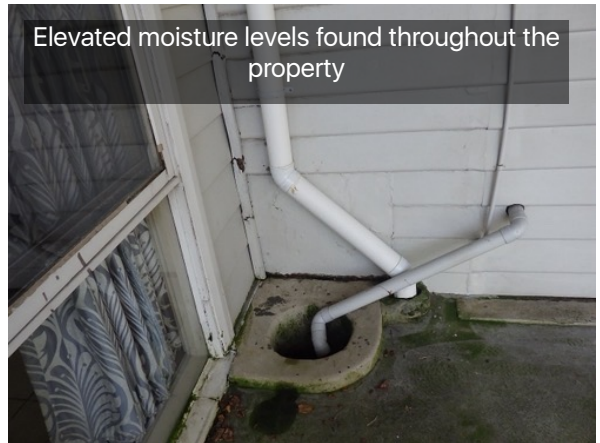
An inspection was carried out using a moisture meter and mechanical means, no live termite activity was identified, however the conditions around the house, including timber in contact with the ground, garden beds up against the house, and the potential moisture levels found around the property all make for termite conducive conditions.

Elevated moisture levels found throughout the property

The application of a post-construction chemical termite barrier is highly recommended for all properties, particularly if live termite activity has been found on the site previously. Such barriers are highly effective in preventing termite attack on any timber building elements throughout the property.
