# Property and Timber Pest Report

Inspection Date: 28 Aug 2026

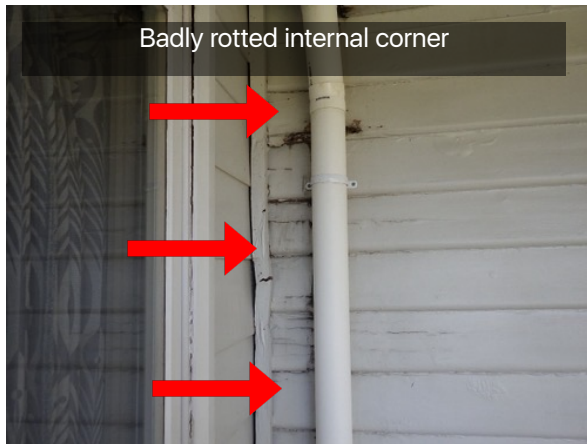
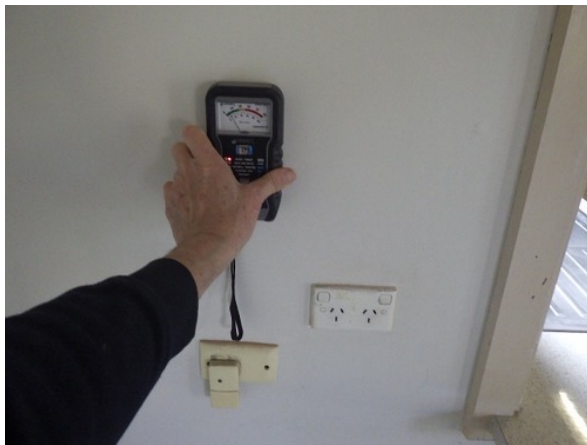
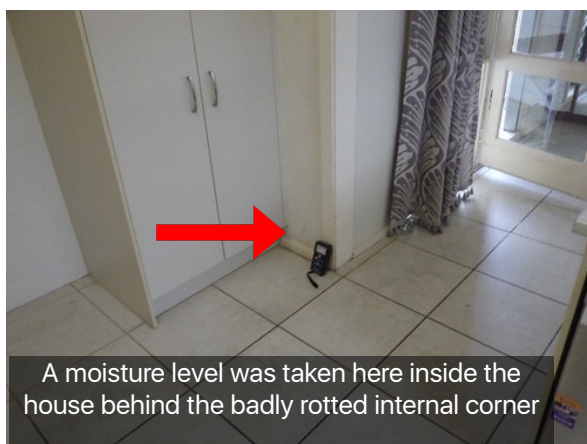
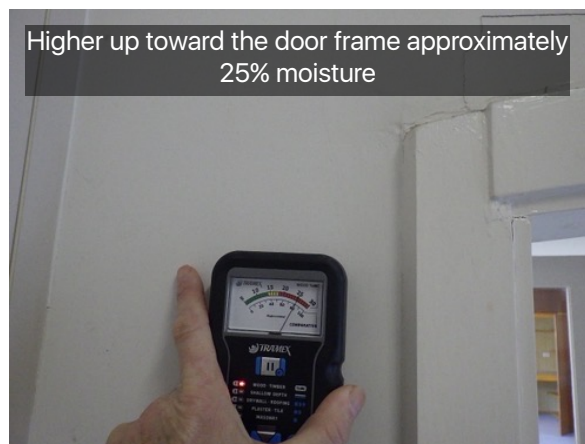
### Major Defect 1.01

**Finding:** Moisture damage

The internal corner of the pergola at the junction between the extension and the original house, the roof is badly rusted allowing moisture to penetrate down into the weatherboards rotting them badly.

When moisture levels were taken inside the house behind the badly moisture affected weatherboards high levels of moisture were detected on the internal wall.

This would infer the stud work in the wall is badly affected by moisture which may also have produced mould.

The metal roof above the pergola will also need to be replaced due to it being rusted through.

This should be done as soon as practical, as if mould is inside the wall this is definitely a health hazard.

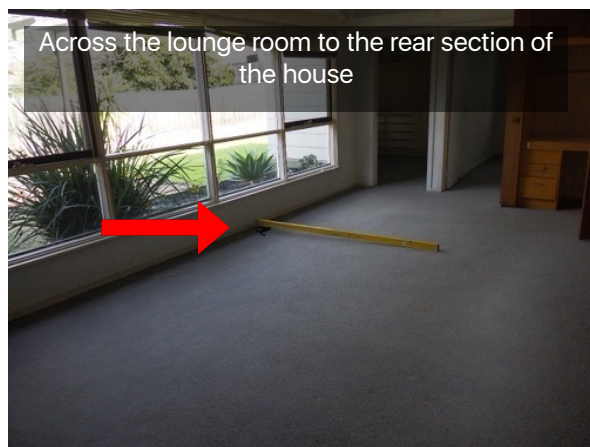
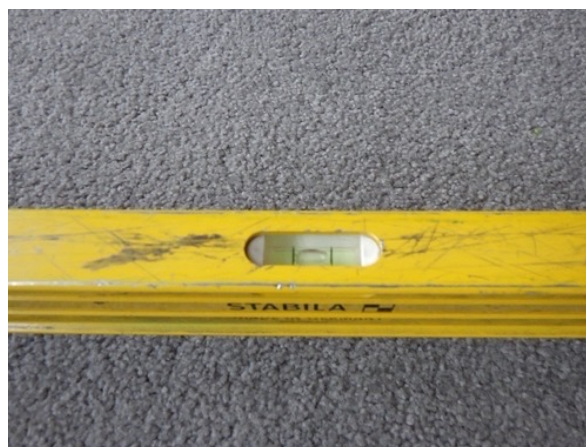
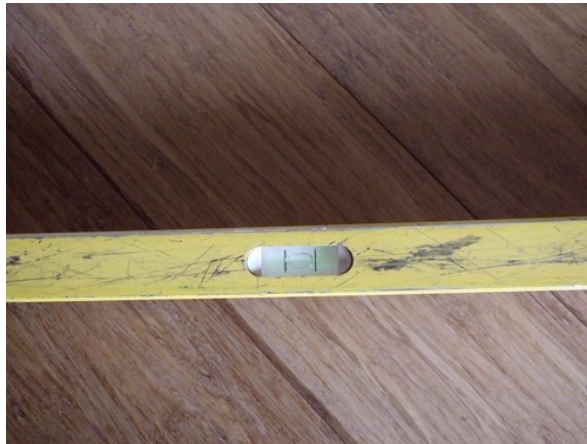
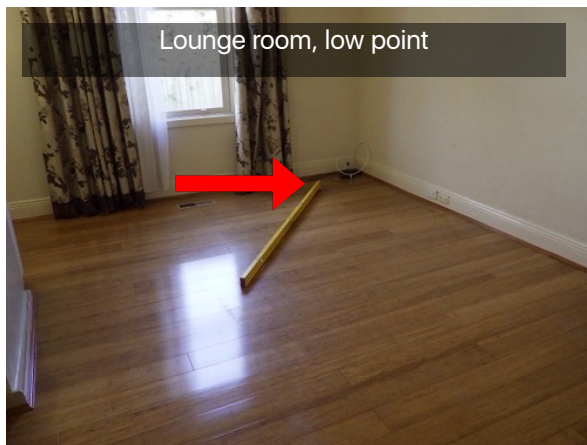
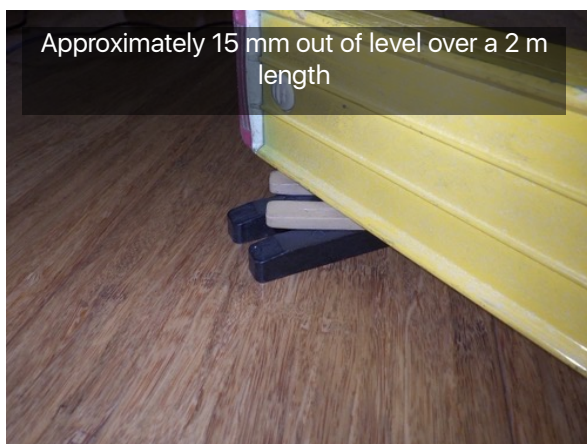
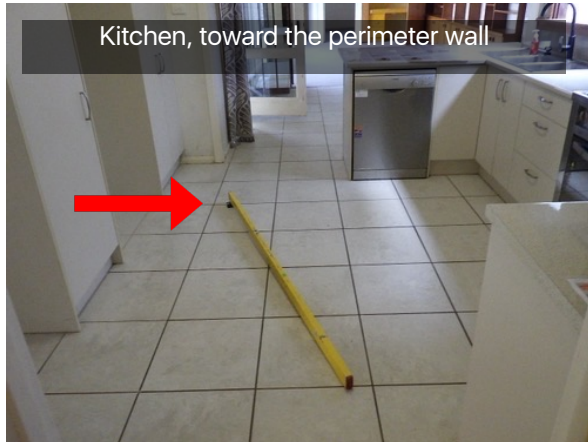
## Major Defect 1.02

The front section of the house would be very difficult to level or stabilise as there is very restricted access.

A stumper could be engaged to provide further advice and the possibilities of what could be done for the property.

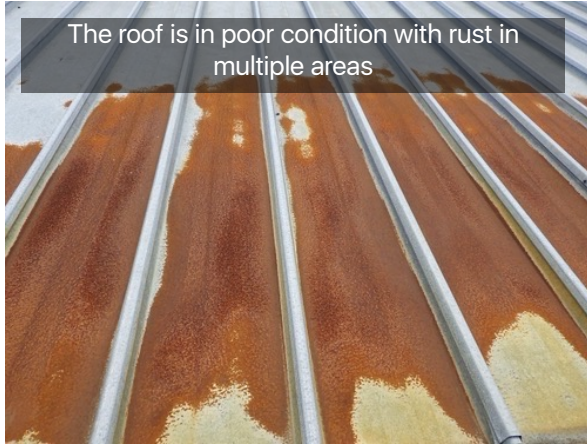
The roof is in poor condition with rust in multiple areas

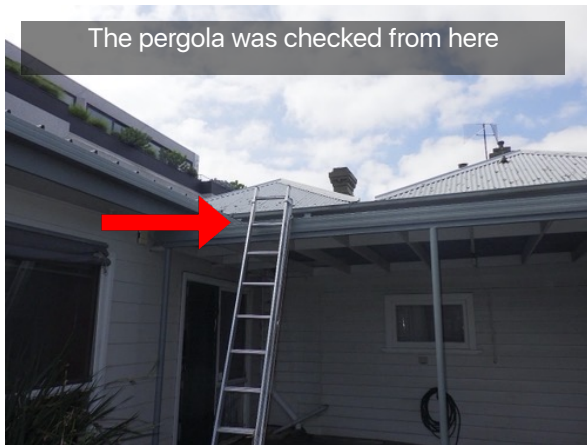
The roof is badly rusted

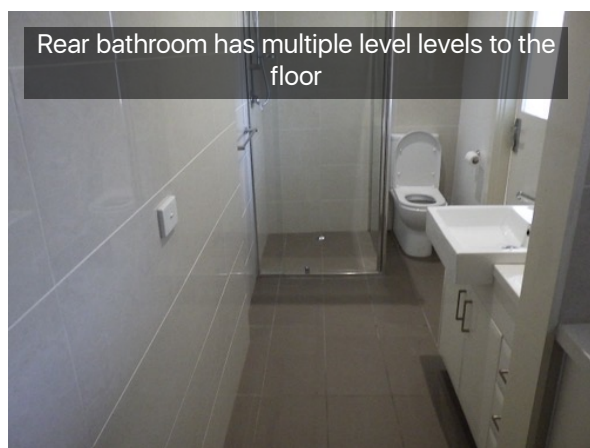
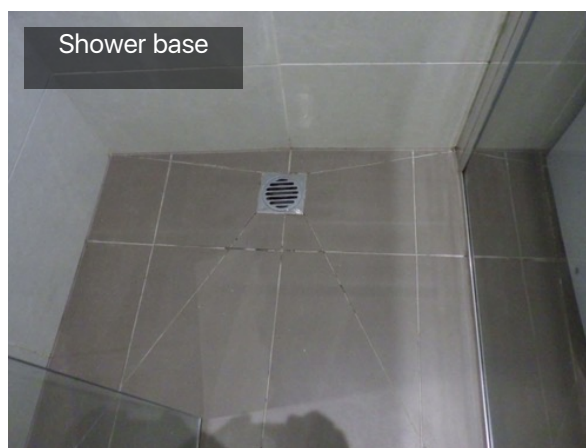
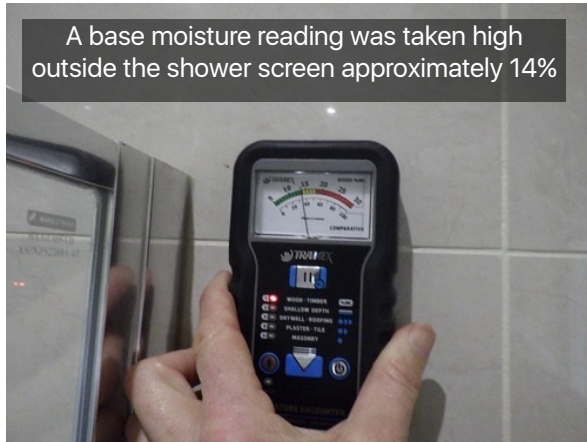
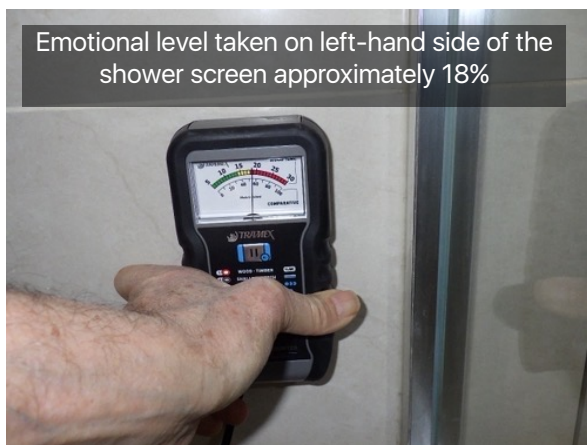
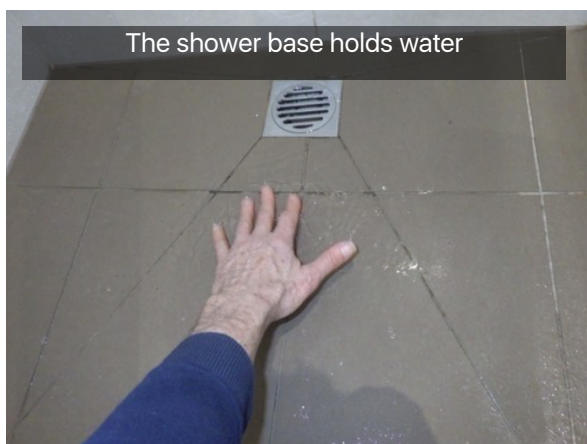
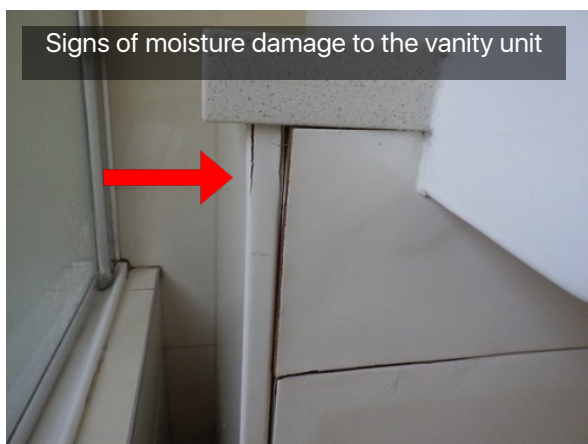
## Minor Defect 2.02

Both the bath and the shower stall to the rear bathroom do not drain efficiently, the shower base hold water.

A plumber could be engaged to possibly send a camera down the sewer lines to find out if there are any blockages or the reason for the slow drainage of the bath and shower base.

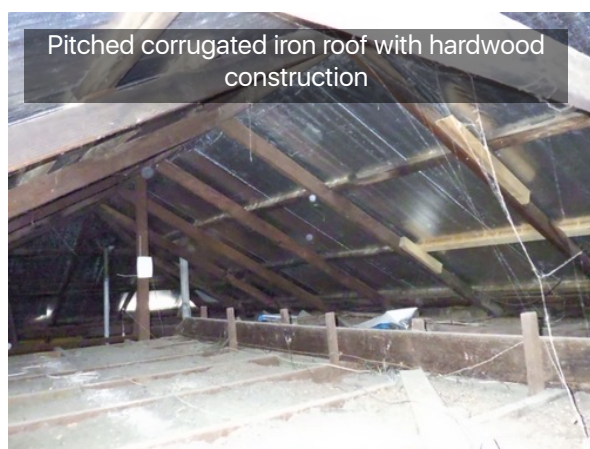
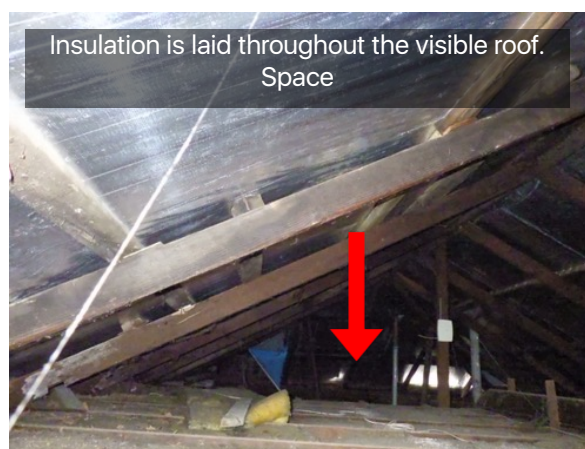
There is insulation laid throughout the roof space.

Collar ties may need to be installed across the width of the roof, a registered builder or qualified carpenter could be consulted.

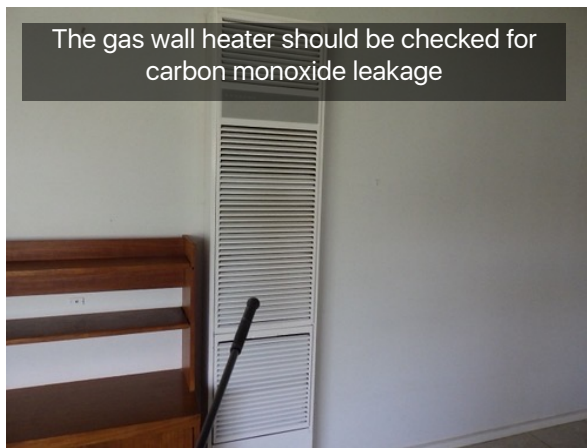
## For your information 3.02

Carbon monoxide is an odourless colourless gas that can be deadly.

The gas heater should be checked by a licensed plumber who specialises in gas before it is used.

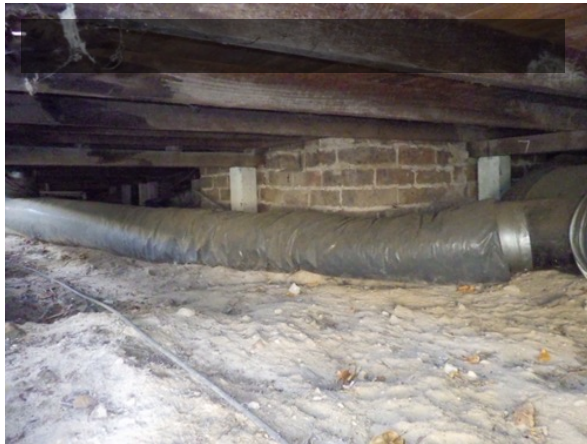
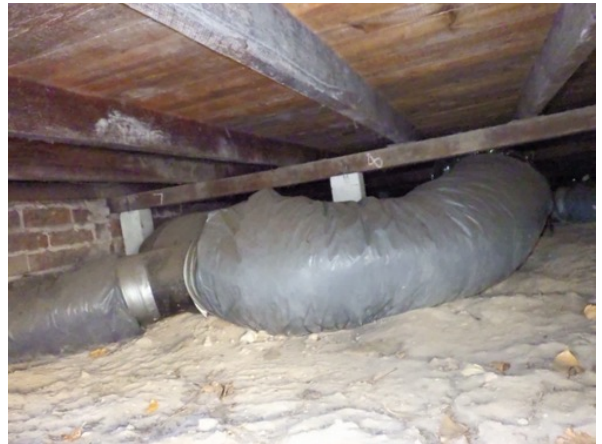
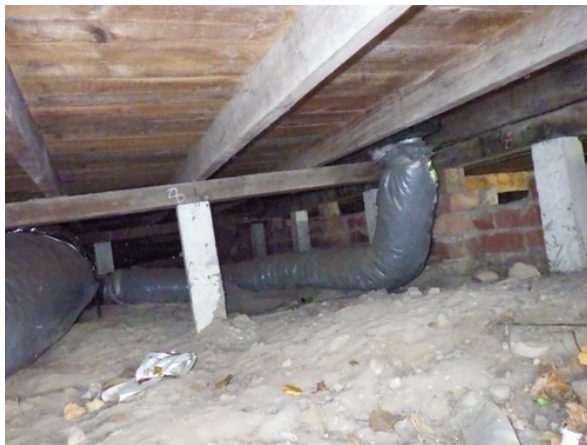
### For your information 3.03

The subfloor could not be accessed.

From what could be seen the ground is dry, the stumps are concrete and the timber subfloor frame is hardwood.

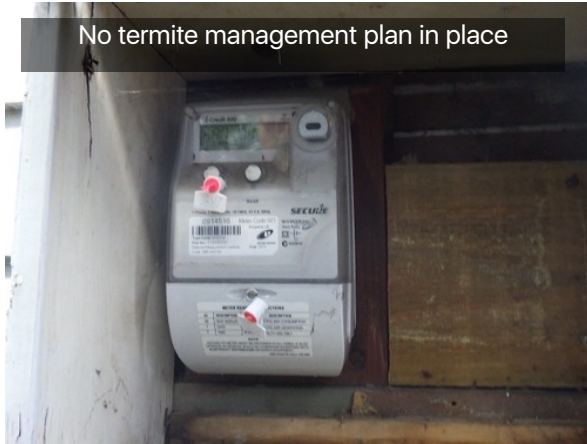
No termite management plan in place

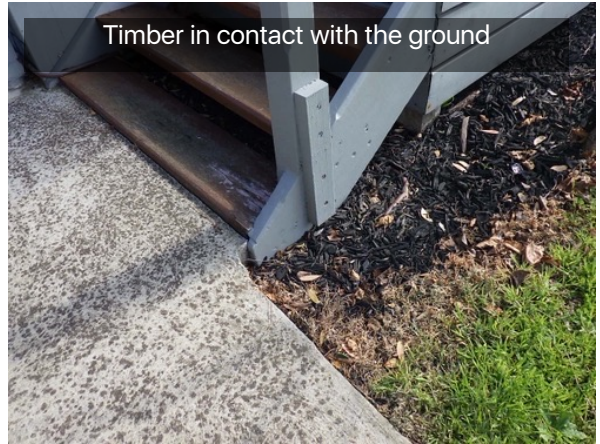
Timber in contact with the ground

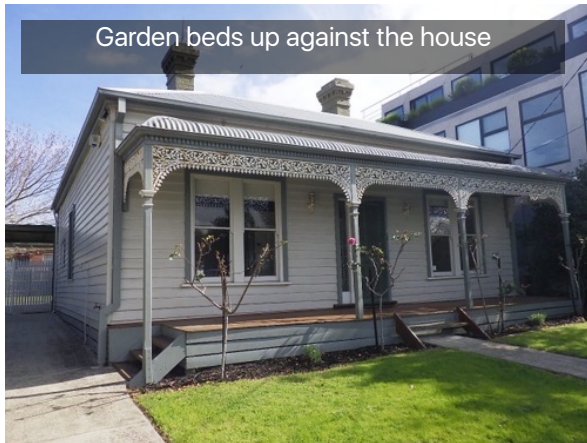
Garden beds up against the house
